**Flood Control Project Maintenance
Levee Inspections**
LMA District Cover Sheet
Spring 2019 Levee Inspection Results

Sutter Maintenance Yard East Levee Sacramento River

Spring 2019 Levee Inspection Results

Levee Inspection Report By Mile - Spring 2019

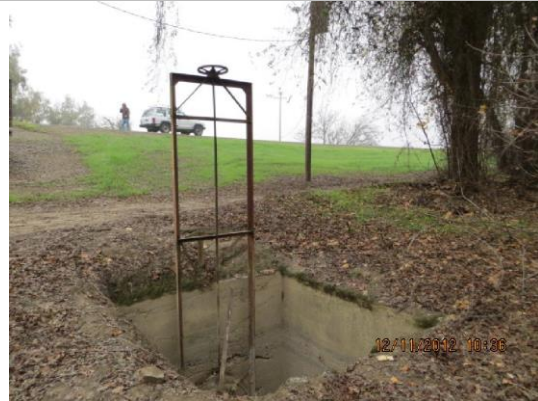
Photo 2 of 3 : UCIP_SP_2019_53403_47322.jpg

FS_ID:53403
DS_ID:17367
EP_NO: 2971
Repair Type: Urgent
Crossing Status: Found
UCIP Comments: 8/30/2018 Same as last inspection; large sink hole/erosion around surge box on WS so crossing remains Urgent (D. Sanoski - DWR UCIP). 4/20/2017 Sink hole behind the WS surge box got a lot bigger after the high water event of Jan/Feb 2017. Pipe also had a leak during that time but not sure if it was due to the sink hole or a faulty slide gate. (DWR Sutter Yard- AFreitag)10/31/2016 No repairs have been made here yet. Sinkhole is still present at the WS surge box. (DWR Sutter Yard- AFreitag)6/6/2016 Pumps were connected to intake pipes and pumping into the WS surge box. The deep sink hole above the surge box measures to be about 6'6" deep from the toe road surface and it appeared to be wet in the bottom indicating the cracks in the concrete may be letting water seep through and wash out the sediment behind the wall. The surge box was full of water so could not observe the sediment build up in the bottom of the box. (DWR Sutter Yard - afreitag)4/14/2016 Deep sink hole above surge box on WS, possibly caused by burrowing, possibly creating conduit for seepage into surge box, which may explain presence of water in box. Recommend pipe be video inspected. Recommend taking another photo in summer to observe possible sediment buildup in box. (DWR UCIP - kfazel)4/2/2015 Pipe has small leak during times of high water. Not sure of the cause. Pumps taken out from the pipe (may be for repairs). Only control board found. LS wing wall minor damage. (DWR Sutter Yard - afreitag)7/2/2014 Same as last inspection. (DWR Sutter Yard - afreitag)12/19/2013 Same as last inspection. (DWR Sutter Yard - afreitag)7/23/2013 Pump motors attached to pipes and running. Think pumps were disconnected during last inspection to keep motors above water for high water season. (DWR Sutter Yard - afreitag)12/11/2012 Pumps taken out from the pipe (may be for repairs). Only control board found. LS wing wall minor damage. (DWR UCIP - pamatya)

Waterside view: concrete surge box

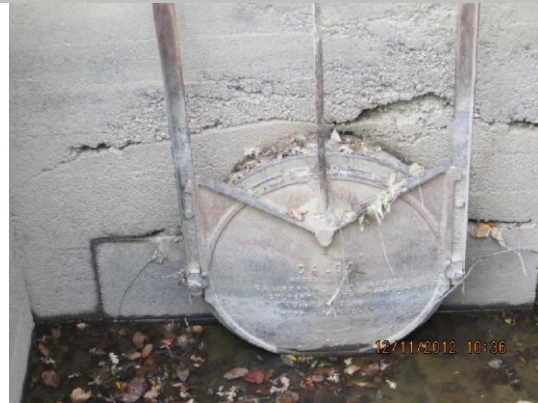
Photo 3 of 3 : UCIP_SP_2019_53403_47321.jpg

FS_ID:53403
DS_ID:17367
EP_NO: 2971
Repair Type: Urgent
Crossing Status: Found
UCIP Comments: 8/30/2018 Same as last inspection; large sink hole/erosion around surge box on WS so crossing remains Urgent (D. Sanoski - DWR UCIP). 4/20/2017 Sink hole behind the WS surge box got a lot bigger after the high water event of Jan/Feb 2017. Pipe also had a leak during that time but not sure if it was due to the sink hole or a faulty slide gate. (DWR Sutter Yard- AFreitag)10/31/2016 No repairs have been made here yet. Sinkhole is still present at the WS surge box. (DWR Sutter Yard- AFreitag)6/6/2016 Pumps were connected to intake pipes and pumping into the WS surge box. The deep sink hole above the surge box measures to be about 6'6" deep from the toe road surface and it appeared to be wet in the bottom indicating the cracks in the concrete may be letting water seep through and wash out the sediment behind the wall. The surge box was full of water so could not observe the sediment build up in the bottom of the box. (DWR Sutter Yard - afreitag)4/14/2016 Deep sink hole above surge box on WS, possibly caused by burrowing, possibly creating conduit for seepage into surge box, which may explain presence of water in box. Recommend pipe be video inspected. Recommend taking another photo in summer to observe possible sediment buildup in box. (DWR UCIP - kfazel)4/2/2015 Pipe has small leak during times of high water. Not sure of the cause. Pumps taken out from the pipe (may be for repairs). Only control board found. LS wing wall minor damage. (DWR Sutter Yard - afreitag)7/2/2014 Same as last inspection. (DWR Sutter Yard - afreitag)12/19/2013 Same as last inspection. (DWR Sutter Yard - afreitag)7/23/2013 Pump motors attached to pipes and running. Think pumps were disconnected during last inspection to keep motors above water for high water season. (DWR Sutter Yard - afreitag)12/11/2012 Pumps taken out from the pipe (may be for repairs). Only control board found. LS wing wall minor damage. (DWR UCIP - pamatya)

Waterside view: slide gate in concrete surge box

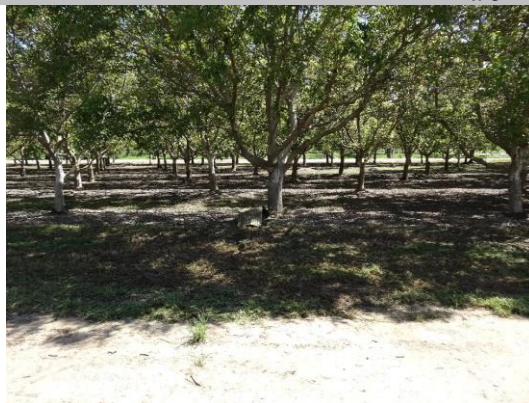
Photo 1 of 3 : UCIP_SP_2019_51747_75075.jpg

FS_ID:51747
DS_ID:17368
EP_NO: N/A
Repair Type: Non-Urgent
Crossing Status: Indicator Found
UCIP Comments: 4/20/2017 Abandoned- needs to be done properly. (DWR Sutter Yard- A Freitag)10/31/2016 Appears abandoned. (DWR Sutter Yard- A Freitag)6/14/2016 Pipe was internally cleaned and camera inspected on 11/5/2015 by Nor-Cal Pipeline Services. Pipe length is 86.7ft long. There is a possible sag in the pipe between the WS riser and LS end as we could not get all the water to drain or be sucked out after the cleaning was done. Internal inspection showed signs of some rusting but no visible holes or other deterioration were found. After the inspection pipe ends were capped and reburied. 4/14/2016 Same as last inspection. Heavy vegetation along WS slope, especially below WS berm, limits visibility. 4/2/2015 WS and LS pipe ends have been dug up in preparation for internal camera inspections. Only CMP riser found. 7/2/2014 Same as last inspection. 12/19/2013 Same as last inspection. 7/23/2013 Same as last inspection.

FIELD_STRUCT_DESC: *ABANDONED* 12-inch drainage pipe of an unknown material through the levee, 14 feet below the crown, not found in 2016. Slide gate in a corrugated metal pipe riser (CMP) on the waterside (WS) slope, found in 2016. [Additional Reference(s): DWR Levee Log, 2002. USACE Sacramento O&M Manual 136, March 1960 (HLM 12.73)].
FS Date: 5/1/2017 10:19:49 AM

View of landside from crown.

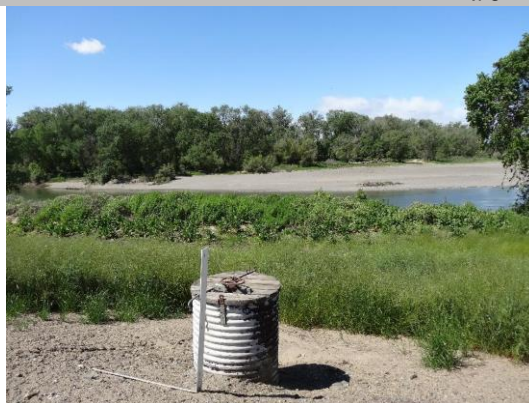
Photo 2 of 3 : UCIP_SP_2019_51747_75076.jpg

WS view: 12-inch slide gate inside CMP riser on WS slope.

Item	DWR UCIP Field Study			39.296965 °	39.296965 °	
				-122.014266 °	-122.014266 °	
DWR ID	17368					
Comment Code						
Inspector Comment						
FS_ID:51747 DS_ID:17368 EP_NO: N/A Repair Type: Non-Urgent Crossing Status: Indicator Found UCIP Comments: 4/20/2017 Abandoned- needs to be done properly. (DWR Sutter Yard- A Freitag)10/31/2016 Appears abandoned. (DWR Sutter Yard- A Freitag)6/14/2016 Pipe was internally cleaned and camera inspected on 11/5/2015 by Nor-Cal Pipeline Services. Pipe length is 86.7ft long. The is a possible sag in the pipe between the WS riser and LS end as we could not get all the water to drain or be sucked out after the cleaning was done. Internal inspection showed signs of some rusting but no visible holes or other deterioration were found. After the inspection pipe ends were capped and reburied. 4/14/2016 Same as last inspection. Heavy vegetation along WS slope, especially below WS berm, limits visibility.4/2/2015 WS and LS pipe ends have been dug up in preparation for internal camera inspections. Only CMP riser found.7/2/2014 Same as last inspection.12/19/2013 Same as last inspection.7/23/2013 Same as last inspection. FIELD_STRUCT_DESC: *ABANDONED* 12-inch drainage pipe of an unknown material through the levee, 14 feet below the crown, not found in 2016. Slide gate in a corrugated metal pipe riser (CMP) on the waterside (WS) slope, found in 2016. [Additional Reference(s): DWR Levee Log, 2002. USACE Sacramento O&M Manual 136, March 1960 (HLM 12.73)]. FS Date: 5/1/2017 10:19:49 AM

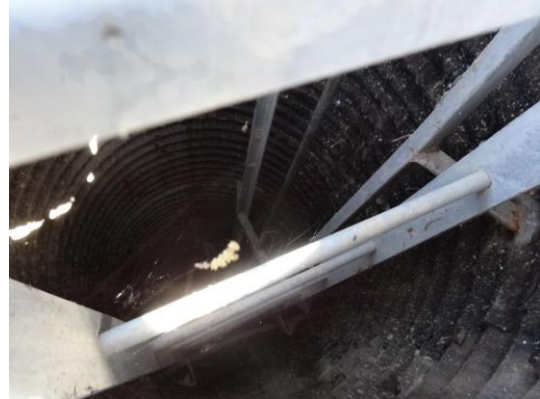
Photo 3 of 3 : UCIP_SP_2019_51747_75077.jpg

WS: slide gate inside CMP riser.

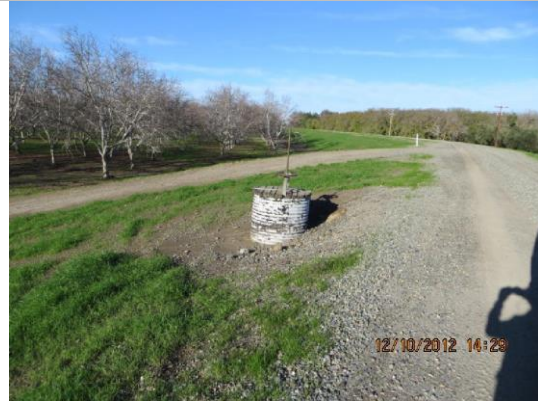
Photo 1 of 3 : UCIP_SP_2019_53404_47336.jpg

FS_ID:53404
DS_ID:17369
EP_NO: 9510
Repair Type: Urgent
Crossing Status: Found
UCIP Comments: 8/30/2018 Same as last inspection; erosion at surge box so crossing remains Urgent (D. Sanoski - DWR UCIP).4/20/2017 Erosion hole at WS surge box has gotten worse after the Jan/Feb 2017 high water event. Pipe also leaked which is believed to be caused by the screwgate not fully closing. (DWR Sutter Yard - AFreitag)10/31/2016 No repairs have been made here yet. Bad erosion stil present at the WS toe distridution box.(DWR Sutter Yard - AFreitag)6/3/2016 Bad erosion stil present all around the WS surge box. Pipes were flowing water at the time of inspection and the bottom of the erosion hole was wet and had standing water in it indicating a leak coming from the surge box. (DWR Sutter Yard - afreitag)4/14/2016 Heavy scour still present around surge box on WS exposing pipe. Levee caved in and severely damaged around surge box. Erosion around CMP riser on WS cited previously not found. (DWR UCIP - kfazel)4/2/2015 Pipe leaks during high water. It is supected that the screw gate does not fully close and may need to be cleaned to allow it to close fully. (DWR Sutter Yard - afreitag)7/2/2014 Same as last inspection. (DWR Sutter Yard - afreitag)12/19/2013 Same as last inspection. (DWR Sutter Yard - afreitag)7/23/2013 Water was flowing from the WS to LS ditch. Not sure where water flow was originating. All erosion problems are still present. (DWR Sutter Yard - afreitag)12/10/2016 Soil erosion around CMP riser and surge concrete box on WS damaged due to overflow. Pump not found. Flap gate missing on WS concrete box. WS slope eroded. Structure might have been used as drainage structure. This needs to be determined during routine inspection. (DWR UCIP - pamatya)

Waterside view: CMP riser on levee slope.

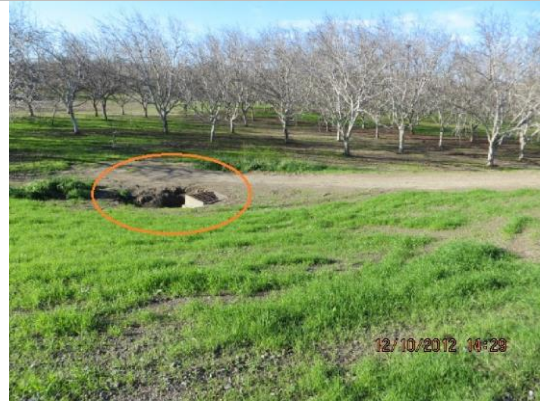
Photo 2 of 3 : UCIP_SP_2019_53404_47334.jpg

FS_ID:53404
 DS_ID:17369
 EP_NO: 9510
 Repair Type: Urgent
 Crossing Status: Found
 UCIP Comments: 8/30/2018 Same as last inspection; erosion at surge box so crossing remains Urgent (D. Sanoski - DWR UCIP).4/20/2017 Erosion hole at WS surge box has gotten worse after the Jan/Feb 2017 high water event. Pipe also leaked which is believed to be caused by the screwgate not fully closing. (DWR Sutter Yard - AFreitag)10/31/2016 No repairs have been made here yet. Bad erosion stil present at the WS toe distridution box.(DWR Sutter Yard - AFreitag)6/3/2016 Bad erosion stil present all around the WS surge box. Pipes were flowing water at the time of inspection and the bottom of the erosion hole was wet and had standing water in it indicating a leak coming from the surge box. (DWR Sutter Yard - afreitag)4/14/2016 Heavy scour still present around surge box on WS exposing pipe. Levee caved in and severely damaged around surge box. Erosion around CMP riser on WS cited previously not found. (DWR UCIP - kfazel)4/2/2015 Pipe leaks during high water. It is supected that the screw gate does not fully close and may need to be cleaned to allow it to close fully. (DWR Sutter Yard - afreitag)7/2/2014 Same as last inspection. (DWR Sutter Yard - afreitag)12/19/2013 Same as last inspection. (DWR Sutter Yard - afreitag)7/23/2013 Water was flowing from the WS to LS ditch. Not sure where water flow was originating. All erosion problems are still present. (DWR Sutter Yard - afreitag)12/10/2016 Soil erosion around CMP riser and surge concrete box on WS damaged due to overflow. Pump not found. Flap gate missing on WS concrete box. WS slope eroded. Structure might have been used as drainage structure. This needs to be determined during routine inspection. (DWR UCIP - pamatya)

Waterside view: overview of concrete surge box

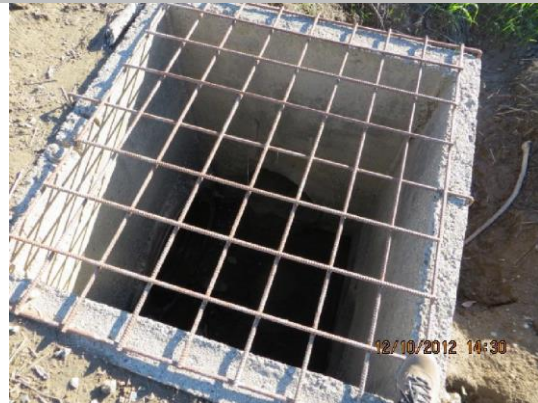
Photo 3 of 3 : UCIP_SP_2019_53404_47333.jpg

FS_ID:53404
DS_ID:17369
EP_NO: 9510
Repair Type: Urgent
Crossing Status: Found
UCIP Comments: 8/30/2018 Same as last inspection; erosion at surge box so crossing remains Urgent (D. Sanoski - DWR UCIP).4/20/2017 Erosion hole at WS surge box has gotten worse after the Jan/Feb 2017 high water event. Pipe also leaked which is believed to be caused by the screwgate not fully closing. (DWR Sutter Yard - AFreitag)10/31/2016 No repairs have been made here yet. Bad erosion stil present at the WS toe distridution box.(DWR Sutter Yard - AFreitag)6/3/2016 Bad erosion stil present all around the WS surge box. Pipes were flowing water at the time of inspection and the bottom of the erosion hole was wet and had standing water in it indicating a leak coming from the surge box. (DWR Sutter Yard - afreitag)4/14/2016 Heavy scour still present around surge box on WS exposing pipe. Levee caved in and severely damaged around surge box. Erosion around CMP riser on WS cited previously not found. (DWR UCIP - kfazel)4/2/2015 Pipe leaks during high water. It is supected that the screw gate does not fully close and may need to be cleaned to allow it to close fully. (DWR Sutter Yard - afreitag)7/2/2014 Same as last inspection. (DWR Sutter Yard - afreitag)12/19/2013 Same as last inspection. (DWR Sutter Yard - afreitag)7/23/2013 Water was flowing from the WS to LS ditch. Not sure where water flow was originating. All erosion problems are still present. (DWR Sutter Yard - afreitag)12/10/2016 Soil erosion around CMP riser and surge concrete box on WS damaged due to overflow. Pump not found. Flap gate missing on WS concrete box. WS slope eroded. Structure might have been used as drainage structure. This needs to be determined during routine inspection. (DWR UCIP - pamatya)

Waterside view: concrete surge box

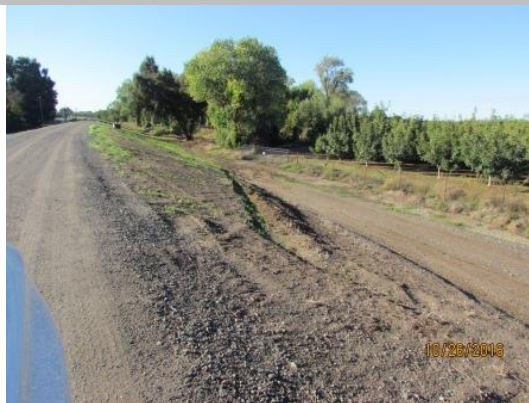
Photo 1 of 1 : SP_2019_ST0003_264_75_20190327_00015.jpg

LM Start	13.43	Rating **	M	Issue No.	75
LM End	13.43	Issue Type +	Ma	Location *	WS
Category	Earthen Levee			GPS Latitude/Longitude	
				Start	End
Item	Slope Stability			39.306919 °	39.306919 °
				-122.013076 °	-122.013076 °
DWR ID	DWR_ST0003_01_f_2016_75				
Comment Code					
S3 : Repair the levee slope damaged by vehicle traffic and prevent access where possible.					
Inspector Comment

View of the slope instability along the waterside slope.

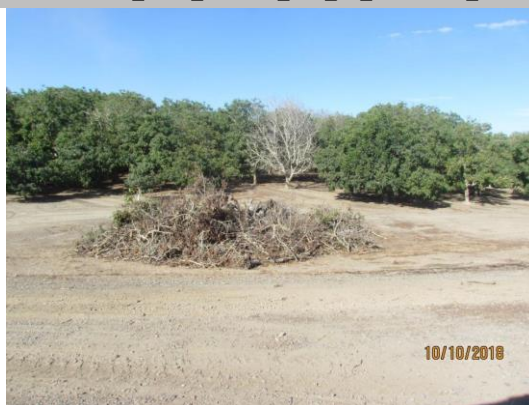
Photo 1 of 1 : SP_2019_ST0003_264_95_20190327_00021.jpg

LM Start	13.77	Rating **	M	Issue No.	95
LM End	13.77	Issue Type +	En	Location *	WS
Category	Earthen Levee			GPS Latitude/Longitude	
				Start	End
Item	Encroachments			39.311710 °	39.311710 °
				-122.012885 °	-122.012885 °
DWR ID	DWR_ST0003_01_f_2018_95				
Comment Code					
PR : Prunings					
Inspector Comment					
Remove the prunings from the waterside toe.

View of the prunings along the waterside toe.

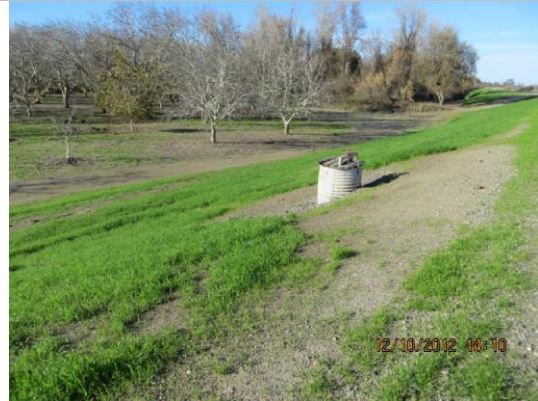
Photo 1 of 3 : UCIP_SP_2019_51750_47349.jpg

Comment Code						
Inspector Comment						
FS_ID:51750 DS_ID:17361 EP_NO: N/A Repair Type: Non-Urgent Crossing Status: Indicator Found UCIP Comments: 4/20/2017 Abandoned- needs to be done properly. (DWR Sutter Yard- AFreitag)10/31/2016 Appears abandoned. WS pipe end buried. (DWR Sutter Yard- AFreitag)6/14/2016 WS pipe end was dug up for a internal camera inspection. The WS slide gate was sealed shut and would not open so the inspection was only done form the WS pipe end to the WS slide gate (33.1ft). The pipe showed some signs of heavy rusting but no visible holes or other signs of deterioration were found. After the inspection the WS pipe end was capped and reburied until further abandonment can be achieved.4/2/2015 Only CMP riser on WS. Pipe has been selected for internal camera inspection. Only CMP riser found on WS.7/2/2014 Same as last inspection.12/19/2013 Same as last inspection.7/23/2013 Same as last inspection. FIELD_STRUCT_DESC: *ABANDONED* 24-inch corrugated metal drainage pipe through the levee, 16 feet below the crown, not found in 2015. Slide gate in a corrugated metal pipe (CMP) riser on the waterside (WS) end, found in 2015. [Additional Reference(s): DWR Levee Log, 2002. USACE Sacramento O&M Manual 136, March 1960 (HLM 13.92)]. FS Date: 5/1/2017 10:32:09 AM

Waterside view: CMP riser with slide gate

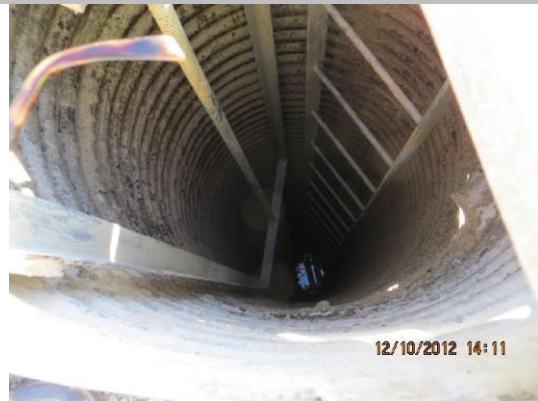
Photo 2 of 3 : UCIP_SP_2019_51750_47348.jpg

Waterside view: inside CMP riser

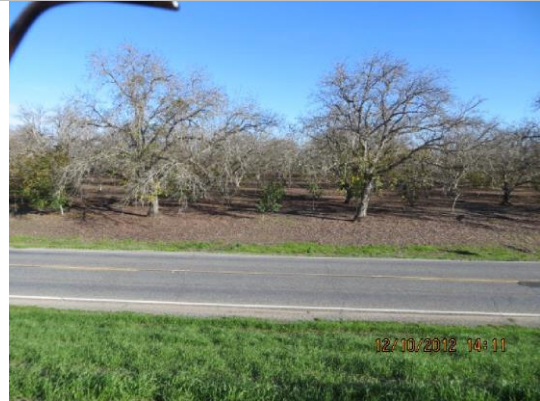
Photo 3 of 3 : UCIP_SP_2019_51750_47347.jpg

Item	DWR UCIP Field Study			39.314025 °	39.314025 °	
				-122.012959 °	-122.012959 °	
DWR ID	17361					
Comment Code						
Inspector Comment						
FS_ID:51750 DS_ID:17361 EP_NO: N/A Repair Type: Non-Urgent Crossing Status: Indicator Found UCIP Comments: 4/20/2017 Abandoned- needs to be done properly. (DWR Sutter Yard- AFreitag)10/31/2016 Appears abandoned. WS pipe end buried. (DWR Sutter Yard- AFreitag)6/14/2016 WS pipe end was dug up for a internal camera inspection. The WS slide gate was sealed shut and would not open so the inspection was only done form the WS pipe end to the WS slide gate (33.1ft). The pipe showed some signs of heavy rusting but no visible holes or other signs of deterioration were found. After the inspection the WS pipe end was capped and reburied until further abandonment can be achieved.4/2/2015 Only CMP riser on WS. Pipe has been selected for internal camera inspection. Only CMP riser found on WS.7/2/2014 Same as last inspection.12/19/2013 Same as last inspection.7/23/2013 Same as last inspection. FIELD_STRUCT_DESC: *ABANDONED* 24-inch corrugated metal drainage pipe through the levee, 16 feet below the crown, not found in 2015. Slide gate in a corrugated metal pipe (CMP) riser on the waterside (WS) end, found in 2015. [Additional Reference(s): DWR Levee Log, 2002. USACE Sacramento O&M Manual 136, March 1960 (HLM 13.92)]. FS Date: 5/1/2017 10:32:09 AM

Landside view: overview- across the county road

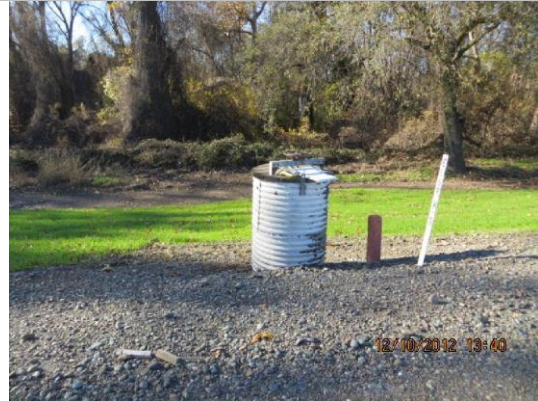
Photo 1 of 3 : UCIP_SP_2019_51752_47356.jpg

FS_ID:51752
DS_ID:17330
EP_NO: 9508
Repair Type: No Action Needed
Crossing Status: Found
UCIP Comments: 4/20/2017 Abandoned- needs to be done so properly. (DWR Sutter Yard- A Freitag) 10/31/2016 Appears abandoned. WS pipe end buried. (DWR Sutter Yard- A Freitag) 6/14/2016 Pipe was internally cleaned and camera inspected on 11/17/2015 by Nor-Cal Pipeline Services. Pipe section through levee is 86ft long and showed some signs of rusting but no visible holes or other deterioration was found. After the inspection the WS end was capped and reburied until further abandonment can be achieved. 4/14/2016 Concrete box on LS cleared of sediment. 4/2/2015 Same as last inspection. Concrete box on LS silted in. If abandoned it should be done so properly. 7/2/2014 Same as last inspection. 12/19/2013 Same as last inspection. 7/23/2013 Same as last inspection.
FIELD_STRUCT_DESC: 24-inch corrugated metal drainage pipe through the levee, 14 feet below the crown. Slide gate in a 36-inch corrugated metal pipe (CMP) riser on the waterside (WS) slope. Concrete distribution box on the landside (LS). (24-inch pipe [HLM 14.5] authorized under Automatic Board Order (ABO) issued as Permit No. 9508, 1974 - Jones). [Additional Reference(s): DWR Levee Log, 2002. USACE Sacramento O&M Manual 136, March 1960 (HLM 14.5)].

Waterside view: CMP riser with slide gate

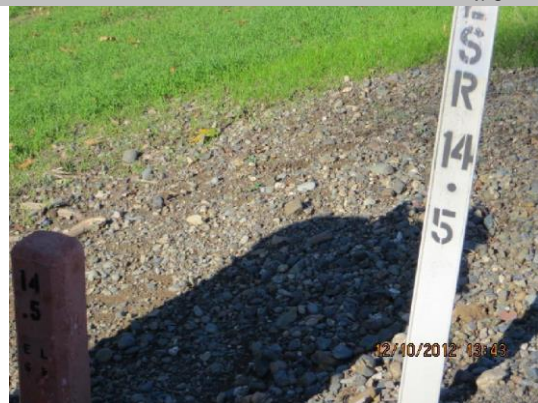
Photo 2 of 3 : UCIP_SP_2019_51752_47361.jpg

Waterside view: levee mile marker

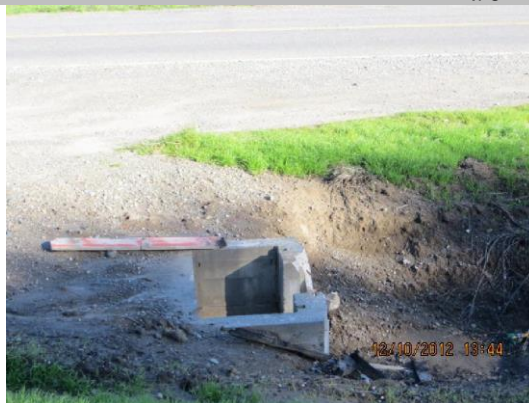
Photo 3 of 3 : UCIP_SP_2019_51752_47360.jpg

Item	DWR UCIP LMA Responsibility			39.321429 °	39.321429 °	
				-122.016079 °	-122.016079 °	
DWR ID	17330					
Comment Code						
Inspector Comment						
FS_ID:51752 DS_ID:17330 EP_NO: 9508 Repair Type: No Action Needed Crossing Status: Found UCIP Comments: 4/20/2017 Abandoned- needs to be done so properly. (DWR Sutter Yard- AFreitag)10/31/2016 Appears abandoned. WS pipe end buried. (DWR Sutter Yard- AFreitag)6/14/2016 Pipe was internally cleaned and camera inspected on 11/17/2015 by Nor-Cal Pipeline Services. Pipe section through levee is 86ft long and showed some signs of rusting but no visible holes or other deterioration was found. After the inspection the WS end was capped and reburied until further abandonment can be achieved.4/14/2016 Concrete box on LS cleared of sediment.4/2/2015 Same as last inspection. Concrete box on LS silted in. If abandoned it should be done so properly.7/2/2014 Same as last inspection.12/19/2013 Same as last inspection.7/23/2013 Same as last inspection. FIELD_STRUCT_DESC: 24-inch corrugated metal drainage pipe through the levee, 14 feet below the crown. Slide gate in a 36-inch corrugated metal pipe (CMP) riser on the waterside (WS) slope. Concrete distribution box on the landside (LS). (24-inch pipe [HLM 14.5] authorized under Automatic Board Order (ABO) issued as Permit No. 9508, 1974 - Jones). [Additional Reference(s): DWR Levee Log, 2002. USACE Sacramento O&M Manual 136, March 1960 (HLM 14.5)]. FS Date: 5/1/2017 10:34:48 AM

Landside view: overview of distribution box

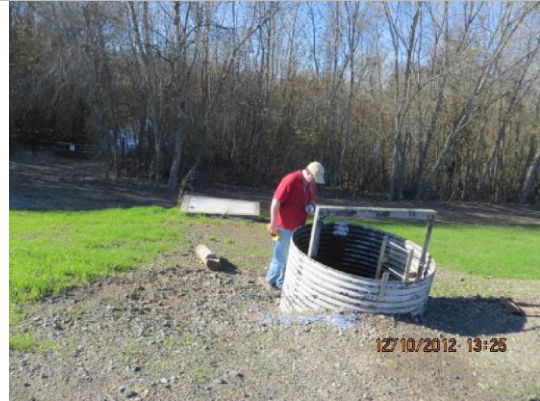
Photo 1 of 3 : UCIP_SP_2019_51753_47363.jpg

FS_ID:51753
DS_ID:17331
EP_NO: 1833
Repair Type: Non-Urgent
Crossing Status: Found
UCIP Comments: 4/20/2017 No leaky pipe marker present during this inspection but it appears that nothing has changed or was repaired since it was labled leaky in 2015. (DWR Sutter Yard- A/Freitag)10/31/2016 Leaky pipe marker was not present at inspection but nothing appears to have changed with this crossing. (DWR Sutter Yard- A/Freitag)6/15/2016 No changes made to this crossing. Leaky pipe marker still present.4/14/2016 Levee slightly caved in one side of surge box on WS4/2/2015 Leaks during high water. Distribution box plugged with cement concrete on LS. Other concrete box plugged with concrete on WS. New steel pipe (about 16 inch diameter) sleeved through CMP pipe. It is visible inside CMP riser.7/2/2014 Same as last inspection.12/19/2013 Same as last inspection.7/23/2013 Same as last inspection.
FIELD_STRUCT_DESC: 42-inch corrugated metal irrigation pipe through the levee, 14.2 feet below the crown. 16-inch (approximate) pipe has been sleeved through the 42-inch corrugated metal pipe (CMP), with annular space pressure grouted. Pump structure on the waterside (WS) bank, not found in 2016. Concrete surge box at the WS toe. Slide gate in a CMP riser on the WS slope. Concrete distribution box on the landside (LS) across River Road. Phone number provided is 916-802-8293. (Permit No. 1833, 1953 - Carter). [Additional Reference(s): DWR Levee Log, 2002. USACE Sacramento O&M Manual 136, March 1960 (HLM 14.55)].

Waterside view: CMP riser with slide gate and surge box

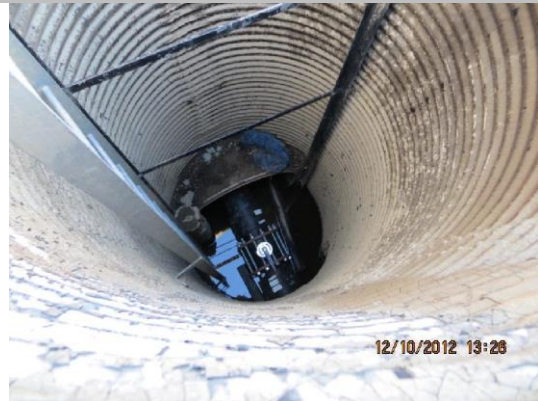
Photo 2 of 3 : UCIP_SP_2019_51753_47362.jpg

Item	DWR UCIP Field Study			39.322279 °		39.322279 °
				-122.015972 °		-122.015972 °
DWR ID	17331					
Comment Code						
Inspector Comment						
FS_ID:51753 DS_ID:17331 EP_NO: 1833 Repair Type: Non-Urgent Crossing Status: Found UCIP Comments: 4/20/2017 No leaky pipe marker present during this inspection but it appears that nothing has changed or was repaired since it was labled leaky in 2015. (DWR Sutter Yard-AFreitag)10/31/2016 Leaky pipe marker was not present at inspection but nothing appears to have changed with this crossing. (DWR Sutter Yard-AFreitag)6/15/2016 No changes made to this crossing. Leaky pipe marker still present.4/14/2016 Levee slightly caved in one side of surge box on WS4/2/2015 Leaks during high water. Distribution box plugged with cement concrete on LS. Other concrete box plugged with concrete on WS. New steel pipe (about 16 inch diameter) sleeved through CMP pipe. It is visible inside CMP riser.7/2/2014 Same as last inspection.12/19/2013 Same as last inspection.7/23/2013 Same as last inspection. FIELD_STRUCT_DESC: 42-inch corrugated metal irrigation pipe through the levee, 14.2 feet below the crown. 16-inch (approximate) pipe has been sleeved through the 42-inch corrugated metal pipe (CMP), with annular space pressure grouted. Pump structure on the waterside (WS) bank, not found in 2016. Concrete surge box at the WS toe. Slide gate in a CMP riser on the WS slope. Concrete distribution box on the landside (LS) across River Road. Phone number provided is 916-802-8293. (Permit No. 1833, 1953 - Carter). [Additional Reference(s): DWR Levee Log, 2002. USACE Sacramento O&M Manual 136, March 1960 (HLM 14.55)]. FS Date: 5/1/2017 10:35:31 AM

Waterside view: new steel pipe sleeved through CMP pipe.

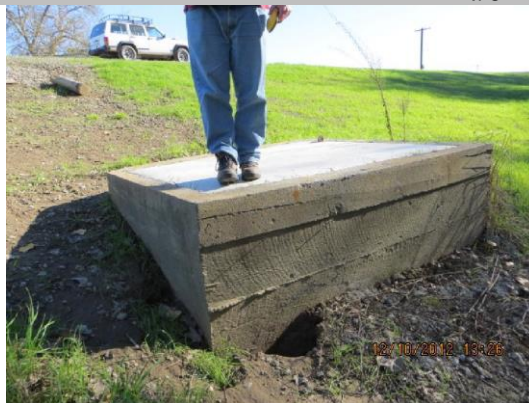
Photo 3 of 3 : UCIP_SP_2019_51753_47366.jpg

FS_ID:51753
DS_ID:17331
EP_NO: 1833
Repair Type: Non-Urgent
Crossing Status: Found
UCIP Comments: 4/20/2017 No leaky pipe marker present during this inspection but it appears that nothing has changed or was repaired since it was labled leaky in 2015. (DWR Sutter Yard- A/Freitag)10/31/2016 Leaky pipe marker was not present at inspection but nothing appears to have changed with this crossing. (DWR Sutter Yard- A/Freitag)6/15/2016 No changes made to this crossing. Leaky pipe marker still present.4/14/2016 Levee slightly caved in one side of surge box on WS4/2/2015 Leaks during high water. Distribution box plugged with cement concrete on LS. Other concrete box plugged with concrete on WS. New steel pipe (about 16 inch diameter) sleeved through CMP pipe. It is visible inside CMP riser.7/2/2014 Same as last inspection.12/19/2013 Same as last inspection.7/23/2013 Same as last inspection.
FIELD_STRUCT_DESC: 42-inch corrugated metal irrigation pipe through the levee, 14.2 feet below the crown. 16-inch (approximate) pipe has been sleeved through the 42-inch corrugated metal pipe (CMP), with annular space pressure grouted. Pump structure on the waterside (WS) bank, not found in 2016. Concrete surge box at the WS toe. Slide gate in a CMP riser on the WS slope. Concrete distribution box on the landside (LS) across River Road. Phone number provided is 916-802-8293. (Permit No. 1833, 1953 - Carter). [Additional Reference(s): DWR Levee Log, 2002. USACE Sacramento O&M Manual 136, March 1960 (HLM 14.55)].

Waterside view: plugged concrete surge box

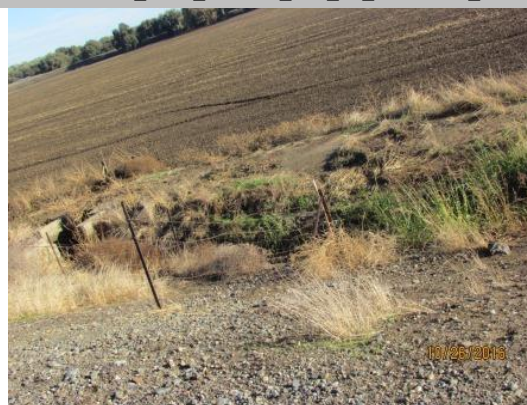
Photo 1 of 1 : SP_2019_ST0003_264_71_20190327_00014.jpg

LM Start	15.17	Rating **	M	Issue No.	71
LM End	15.48	Issue Type +	En	Location *	LS
Category	Earthen Levee			GPS Latitude/Longitude	
				Start	End
Item	Encroachments			39.330578 °	39.333842 °
				-122.018485 °	-122.022225 °
DWR ID	DWR_ST0003_01_f_2016_71				
Comment Code					
DT : Ditch					
Inspector Comment

View of a ditch along the landside toe.

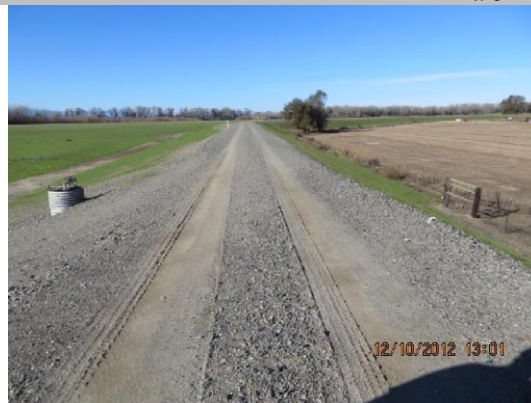
Photo 1 of 3 : UCIP_SP_2019_51755_47371.jpg

FS_ID:51755
DS_ID:17333
EP_NO: 9506
Repair Type: Non-Urgent
Crossing Status: Found
UCIP Comments: 4/20/2017 Both pipe ends were underwater during site visit but it appears to be in good condition. (DWR Sutter Yard-AFreitag)10/31/2016 Minor erosion caused by rain runoff starting at the top of the WS headwall. REst of crossing appears in good condition. (DWR Sutter Yard- AFreitag)6/15/2016 Both pipe ends were underwater but appear to be in good condition.4/2/2015 Pipe and ditches were full of water. Everything seemed to be in good shape.Water full on inlet and outlet of the structure.7/2/2014 Same as last inspection.12/19/2013 Same as last inspection.7/23/2013 Same as last inspection.
FIELD_STRUCT_DESC: 24-inch irrigation pipe of an unknown material through the levee, 16.5 feet below the crown. Pump in the floodway. Irrigation transfer ditch on the waterside (WS) to concrete surge box at the WS toe. Slide gates in a corrugated metal pipe (CMP) riser on the WS slope. Discharges into a concrete distribution box at the landside (LS) toe. (Automatic Board Order (ABO) issued as Permit No. 9506, 1974 - Carter). [Additional Reference(s): DWR Levee Log, 2002. USACE Sacramento O&M Manual 136, March 1960 (HLM 15.46)].

Crown view: overview (both sides of the levee)

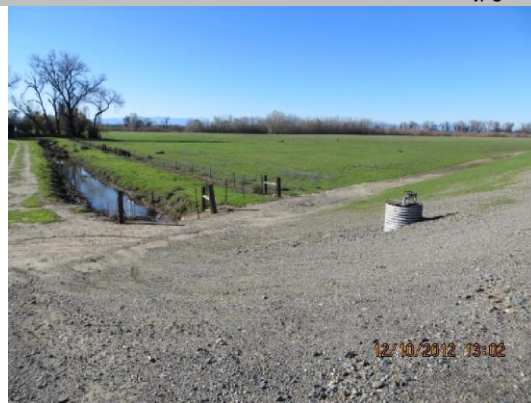
Photo 2 of 3 : UCIP_SP_2019_51755_47370.jpg

Waterside view: CMP riser, inlet box and water transfer ditch

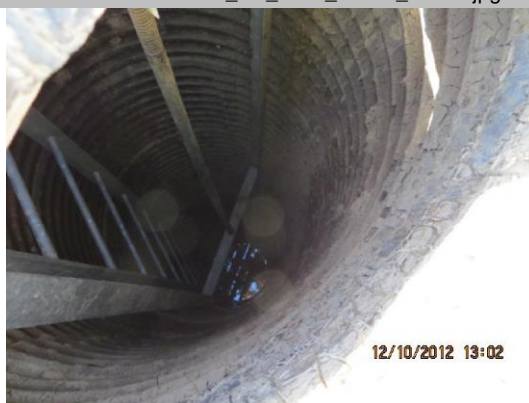
Photo 3 of 3 : UCIP_SP_2019_51755_47369.jpg

Item	DWR UCIP Field Study			39.333868 °	39.333868 °	
				-122.022243 °	-122.022243 °	
DWR ID	17333					
Comment Code						
Inspector Comment						
FS_ID:51755 DS_ID:17333 EP_NO: 9506 Repair Type: Non-Urgent Crossing Status: Found UCIP Comments: 4/20/2017 Both pipe ends were underwater during site visit but it appears to be in good condition. (DWR Sutter Yard-AFreitag)10/31/2016 Minor erosion caused by rain runoff starting at the top of the WS headwall. REst of crossing appears in good condition. (DWR Sutter Yard- AFreitag)6/15/2016 Both pipe ends were underwater but appear to be in good condition.4/2/2015 Pipe and ditches were full of water. Everything seemed to be in good shape.Water full on inlet and outlet of the structure.7/2/2014 Same as last inspection.12/19/2013 Same as last inspection.7/23/2013 Same as last inspection. FIELD_STRUCT_DESC: 24-inch irrigation pipe of an unknown material through the levee, 16.5 feet below the crown. Pump in the floodway. Irrigation transfer ditch on the waterside (WS) to concrete surge box at the WS toe. Slide gates in a corrugated metal pipe (CMP) riser on the WS slope. Discharges into a concrete distribution box at the landside (LS) toe. (Automatic Board Order (ABO) issued as Permit No. 9506, 1974 - Carter). [Additional Reference(s): DWR Levee Log, 2002. USACE Sacramento O&M Manual 136, March 1960 (HLM 15.46)]. FS Date: 5/1/2017 10:38:21 AM

Waterside view: inside CMP riser

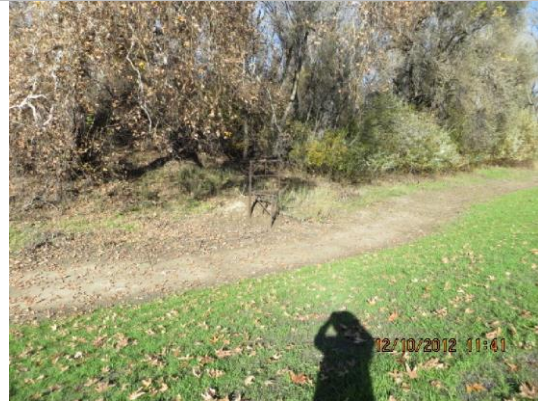
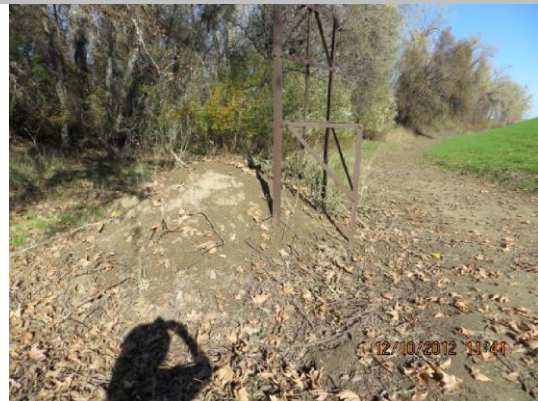
Photo 1 of 3 : UCIP_SP_2019_51760_47380.jpg

Comment Code					
Inspector Comment					
FS_ID:51760 DS_ID:17349 EP_NO: 9500 Repair Type: Non-Urgent Crossing Status: Indicator Found UCIP Comments: 4/20/2017 Abandoned- needs to be done properly. (DWR Sutter Yard- AFreitag)11/1/2016 Abandoned. (DWR Sutter Yard- AFreitag)6/15/2016 Abandoned- WS slide gate and LS distribution box are silted over.4/16/2016 Same as last inspection. Appears abandoned and should be done so properly.4/2/2015 WS slide gate and LS distribution box are still silted over.Seems abandoned as slide gate and distribution box silted.7/2/2014 Same as last inspection.12/19/2013 Same as last inspection.7/23/2013 Same as last inspection. FIELD_STRUCT_DESC: *ABANDONED* 48-inch corrugated metal irrigation and drainage pipe through the levee, 17 feet below the crown, not found in 2016. Slide gate on the waterside (WS), found in 2016. 8-inch steel pipe sleeved through the 48-inch pipe during the summer months, not found in 2016. Discharges into a concrete distribution box on the landside (LS) toe. (Automatic Board Order (ABO) issued as Permit No. 9500, 1974 - Zumwalt Orchards, Inc.). [Additional Reference(s): DWR Levee Log, 2002. USACE Sacramento O&M Manual 136, March 1960 (HLM 16.42)]. FS Date: 5/1/2017 10:42:09 AM

LM Start	16.43	Rating **	M	Issue No.	185 (cont)
LM End	16.43	Issue Type +	En	Location *

Waterside view: overview of slide gate

Waterside view: slide gate on steel structure

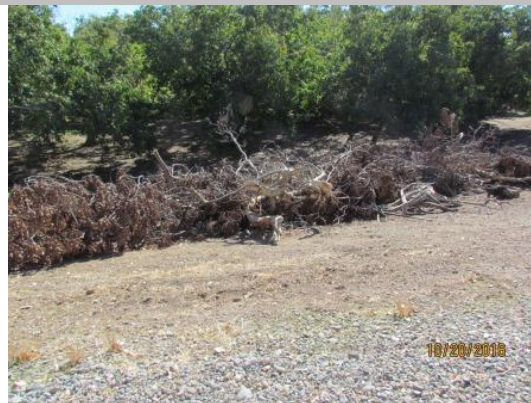
Photo 1 of 1 : SP_2019_ST0003_264_68_20190327_00013.jpg

LM Start	16.96	Rating **	M	Issue No.	68
LM End	16.96	Issue Type +	En	Location *	LS
Category	Earthen Levee			GPS Latitude/Longitude	
				Start	End
Item	Encroachments			39.347312 °	39.347312 °
				-122.015137 °	-122.015137 °
DWR ID	DWR_ST0003_01_f_2016_68				
Comment Code					
PR : Prunings					
Inspector Comment					
Remove prunings from the landside toe.

View of the prunings along the landside toe.

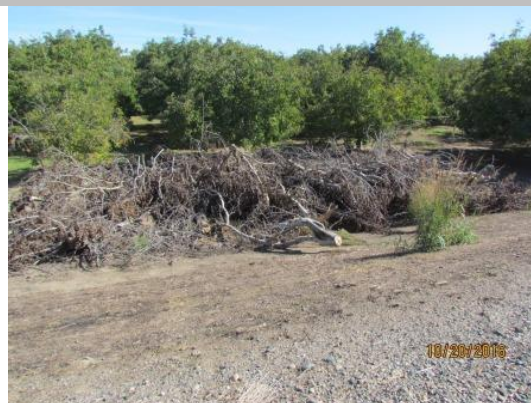
Photo 1 of 1 : SP_2019_ST0003_264_66_20190327_00012.jpg

LM Start	17.42	Rating **	M	Issue No.	66
LM End	17.42	Issue Type +	En	Location *	LS
Category	Earthen Levee			GPS Latitude/Longitude	
				Start	End
Item	Encroachments			39.351322 °	39.351322 °
				-122.009348 °	-122.009348 °
DWR ID	DWR_ST0003_01_f_2016_66				
Comment Code					
PR : Prunings					
Inspector Comment					
Remove prunings from the landside toe.

View of the prunings along the landside toe.

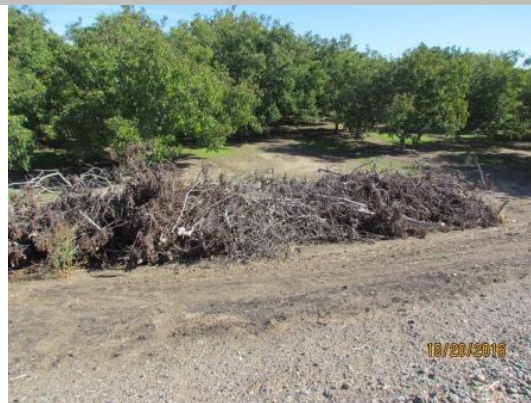
Photo 1 of 1 : SP_2019_ST0003_264_65_20190327_00011.jpg

LM Start	17.51	Rating **	M	Issue No.	65
LM End	17.51	Issue Type +	En	Location *	LS
Category	Earthen Levee			GPS Latitude/Longitude	
				Start	End
Item	Encroachments			39.352615 °	39.352615 °
				-122.009247 °	-122.009247 °
DWR ID	DWR_ST0003_01_f_2016_65				
Comment Code					
PR : Prunings					
Inspector Comment					
Remove prunings from the landside toe.

View of the prunings along the landside toe.

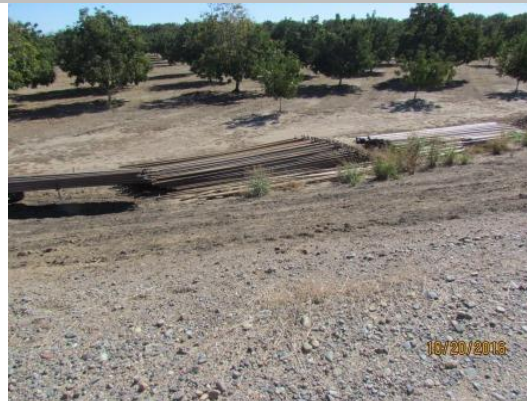
Photo 1 of 1 : SP_2019_ST0003_264_63_20190327_00010.jpg

LM Start	17.97	Rating **	M	Issue No.	63
LM End	18.05	Issue Type +	En	Location *	LS
Category	Earthen Levee			GPS Latitude/Longitude	
				Start	End
Item	Encroachments			39.358920 °	39.359547 °
				-122.007537 °	-122.006293 °
DWR ID	DWR_ST0003_01_f_2016_63				
Comment Code					
MA : Material					
Inspector Comment					
Remove materials from the landside toe.

View of the materials along the landside toe.

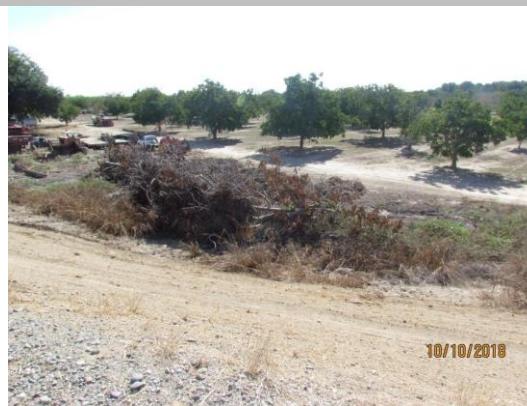
Photo 1 of 1 : SP_2019_ST0003_264_101_20190327_00026.jpg

LM Start	18.07	Rating **	M	Issue No.	101
LM End	18.07	Issue Type +	En	Location *	LS
Category	Earthen Levee			GPS Latitude/Longitude	
				Start	End
Item	Encroachments			39.359692 °	39.359692 °
				-122.005892 °	-122.005892 °
DWR ID	DWR_ST0003_01_f_2018_101				
Comment Code					
PR : Prunings					
Inspector Comment					
Remove the prunings from the landside toe.

View of the prunings along the landside toe.

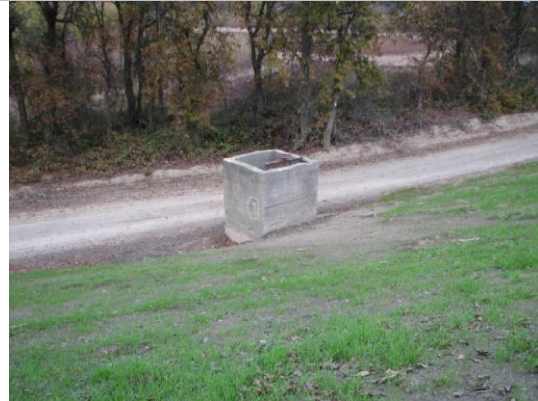
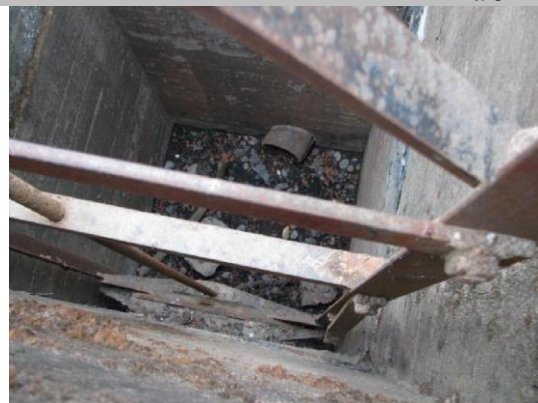
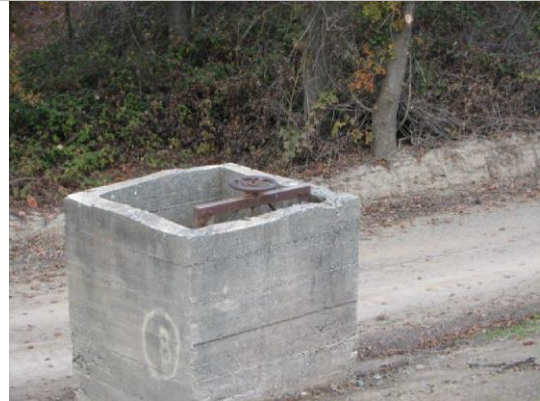
FS_ID:51766
DS_ID:17343
EP_NO: 9502
Repair Type: Non-Urgent
Crossing Status: Found
UCIP Comments: 4/20/2017 Abandoned- needs to be done properly. (DWR Sutter Yard- A Freitag) 11/1/2016 Abandoned. (DWR Sutter Yard- A Freitag) 6/3/2016 Abandoned crossing. 4/2/2015 Same as last inspection. Vertical pump on bank not found as bank is not accessible. An abandoned electrical switch found on waterside. Landside distribution box is filled with debris and soil. Crossing appears abandoned and should be verified as having been done so properly.

7/2/2014 Same as last inspection. 12/19/2013 Same as last inspection. 7/24/2013 Same as last inspection.
FIELD_STRUCT_DESC: *ABANDONED* 36-inch corrugated metal irrigation pipe through the levee, 18 feet below the crown. Vertical pump on the waterside (WS) bank, not found in 2015. Slide gate in a concrete box on the WS toe. Pipe discharges into a concrete distribution box on the landside (LS) toe. Pole on the WS shoulder and an abandoned electrical switch found on the WS. (Automatic Board Order (ABO) issued as Permit No. 9502, 1974 - Coffman). (Additional Related Permit(s): Permit No. 11540, 1976 - Wilearlee Walnuts). [Additional Reference(s): DWR Levee Log, 2002. USACE Sacramento O&M Manual 136, March 1960 (HLM 18.22)].
FS Date: 5/1/2017 10:49:09 AM

LM Start	18.19	Rating **	M	Issue No.	189 (cont)
LM End	18.19	Issue Type +	En	Location *

Waterside view: overview of gate riser

Waterside view: inside gate riser

Waterside view: concrete gate riser

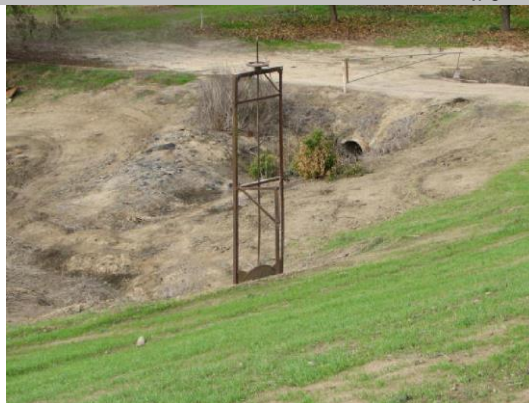
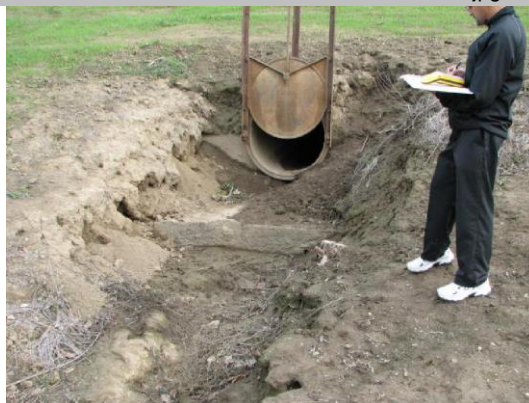
Comment Code						
Inspector Comment						
FS_ID:51770						
DS_ID:17345						
EP_NO: N/A						
Repair Type: No Action Needed						
Crossing Status: Found						
UCIP Comments: 4/20/2017 Crossing appears to be in good condition. (DWR Sutter Yard- AFreitag)11/1/2016 Crossing appears to be in good condition. (DWR Sutter Yard- AFreitag)6/16/2016 Pipe was internally cleaned and camera inspected on 11/19/2015 by Nor-Cal Pipeline Services. Pipe is 155ft in total length and the inpsection showed some minor rusting but no holes or other deformations were found. Pipe is still used by the landowner for irrigation and the sloughing near the WS end was repaired and rocked to prevent future sloughing or erosion.4/14/2016 Sloughing repaired by Sutter Yard with rock revetment.4/2/2015 Same as last inspection. Pipe has been selected for internal camera inspection.Sloughing at outlet and levee slope is damaged due to sloughing.7/2/2014 It is not an abandoned crossing. Sloughing at outlet and levee slope is damaged due to sloughing.12/19/2013 Same as last inspection.7/24/2013 Same as last inspection.

LM Start	18.61	Rating **	A/W	Issue No.	191 (cont)
LM End	18.61	Issue Type +	Ma	Location *

Waterside view: overview of sliding gate structure

Waterside view: outlet pipe with concrete headwall and floor apron.

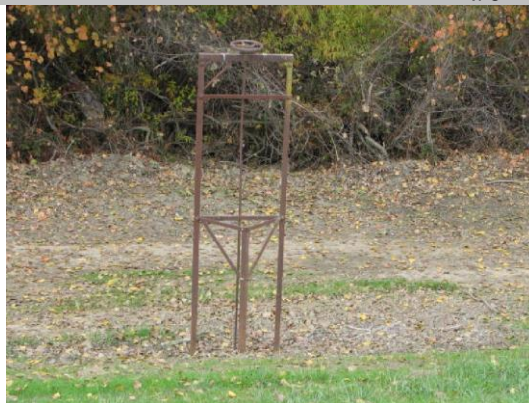
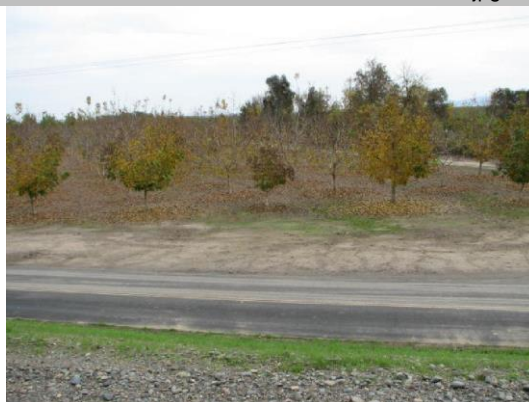
Comment Code					
Inspector Comment					
FS_ID:51773 DS_ID:17347 EP_NO: N/A Repair Type: No Action Needed Crossing Status: Found UCIP Comments: 4/20/2017 Abandoned- plugged. (DWR Sutter Yard-AFreitag)11/1/2016 Abandoned/plugged. (DWR Sutter Yard-AFreitag)6/16/2016 Internal camera inspection was done on 11/19/2015 by Nor-Cal Pipeline Servies. Pipe was inspected starting from the WS end and inspected upto the grout plug that is 13.7ft into the pipe. Pipe was then capped and reburied until further abandonment can be achieved.4/2/2015 WS end of pipe was dug up in preparation for internal camera inspection. Only steel slide gate structure found on WS.7/2/2014 Same as last inspection.12/19/2013 Same as last inspection.7/24/2013 Same as last inspection. FIELD_STRUCT_DESC: *ABANDONED* 36-inch corrugated metal drainage pipe through the levee, 21.7 feet below the crown. Slide gate at the waterside (WS) toe. Pipe grouted on the WS end. [Additional Reference(s): DWR Levee Log, 2002. USACE Sacramento O&M Manual 136, March 1960 (HLM 19.24)]. FS Date: 5/1/2017 10:55:06 AM

Waterside view: overview of abandoned slide gate structure

LM Start	19.19	Rating **	A/W	Issue No.	193 (cont)
LM End	19.19	Issue Type +	Ma	Location *

Landside view: overview (no pipes)

WS pipe end and screw gate

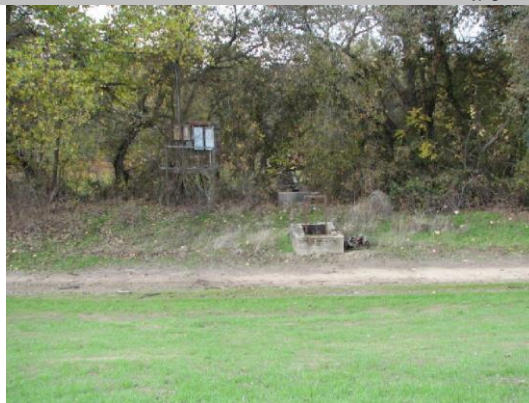
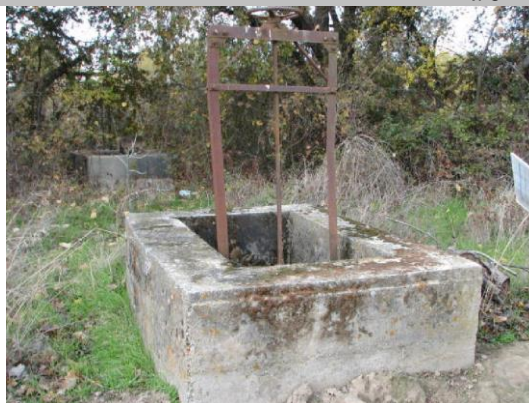
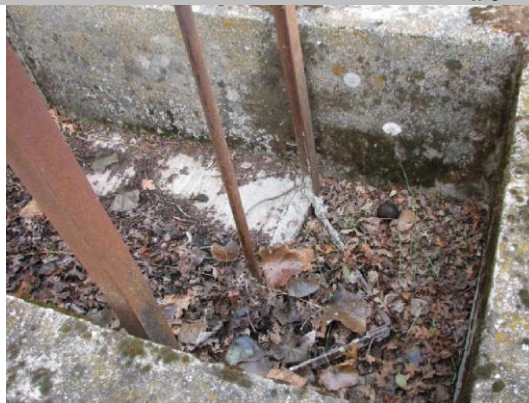
LM Start	19.97	Rating **	M	Issue No.	195 (cont)
LM End	19.97	Issue Type +	En	Location *

Waterside view: overview

Waterside view: gate riser with slide gate

Item	DWR UCIP Field Study			39.380501 °		39.380501 °
				-121.993546 °		-121.993546 °
DWR ID	17370					
Comment Code						
Inspector Comment						
FS_ID:51776 DS_ID:17370 EP_NO: 9496 Repair Type: Non-Urgent Crossing Status: Found UCIP Comments: 4/20/2017 Abandoned- needs to be done properly. (DWR Sutter Yard- A Freitag)11/1/2016 Abandoned. (DWR Sutter Yard- A Freitag)6/3/2016 Abandoned crossing4/2/2015 Same as last inspection. Only one pump found on WS. An abandoned surge box found on WS and pipe is grouted with cement. Two 16-inch steel pipe found on pump station along with two electrical conduits. A concrete distribution box found on LS with 20-inch CMP. Appears abandoned crossing.7/2/2014 Same as last inspection.12/19/2013 Same as last inspection.7/24/2013 Same as last inspection. FIELD_STRUCT_DESC: *ABANDONED* 20-inch corrugated metal irrigation pipe through the levee, 19.8 feet below the crown. (Not 24-inch pipe, as stated in the O&M Manual, Automatic Board Order, and Levee Log). Two vertical pumps on a pile structure on the waterside (WS) bank (one pump found in 2015). Slide gate in a concrete surge box on the waterside (WS) berm. Discharges into a concrete distribution box on the landside (LS) across the county road. Switch board on the platform on the WS bank. (Automatic Board Order (ABO) issued as Permit No. 9496, 1974 - Womble). [Additional Reference(s): DWR Levee Log, 2002. USACE Sacramento O&M Manual 136, March 1960 (HLM 20.05)]. FS Date: 5/1/2017 10:57:25 AM

Waterside view: abandoned pipe with cement grouting

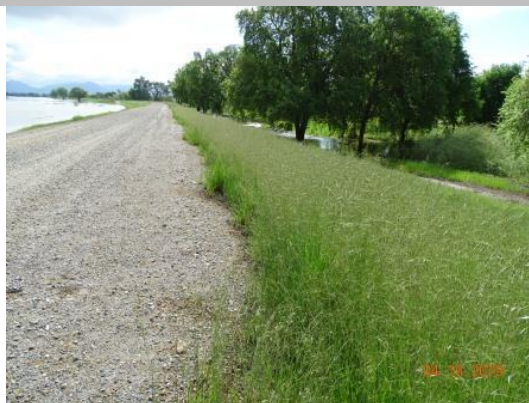
Photo 1 of 1 : SP_2019_ST0003_265_7_20190418_00004.jpg

LM Start	0.00	Rating **	M	Issue No.	7
LM End	2.20	Issue Type +	Ma	Location *	LS
Category	Earthen Levee			GPS Latitude/Longitude	
				Start	End
Item	Vegetation			39.232138 °	39.227873 °
				-121.995825 °	-121.958932 °
DWR ID	DWR_ST0003_02_s_2017_7				
Comment Code					
V1 : Control annual grass and weeds on the levee slopes and easements.					
Inspector Comment

View of the vegetation on the landside slope. Spring 2019.

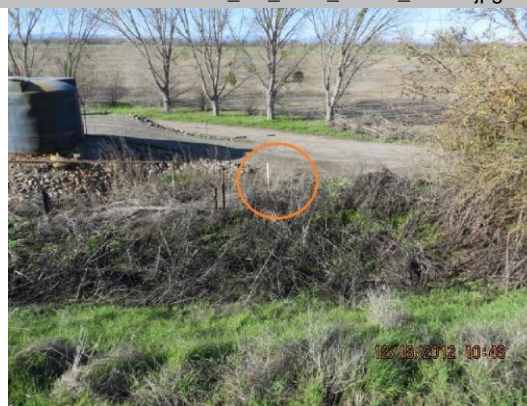
Photo 1 of 3 : UCIP_SP_2019_49161_47480.jpg

LM Start	1.20	Rating **	M	Issue No.	8 (cont)
LM End	1.20	Issue Type +	En	Location *

Landside view: overview gasoline indicator

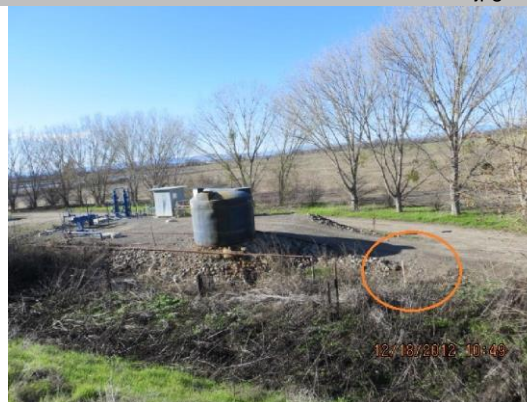
Photo 2 of 3 : UCIP_SP_2019_49161_47479.jpg

Comment Code						
Inspector Comment						
FS_ID:49161 DS_ID:17531 EP_NO: 13534 Repair Type: Non-Urgent Crossing Status: Indicator Found UCIP Comments: 6/3/2016 Crossing appears to be in good condition.4/6/2015 Same as last inspection. May need to add more substantial gasoline markers.7/7/2014 Same as last inspection.12/19/2013 Same as last inspection.7/22/2013 Same as last inspection. FIELD_STRUCT_DESC: 2.5-inch asphalt coated steel gas pipeline through the levee, 2.5 feet below the crown. A gas line marker found on the landside (LS). (Permit No. 13534, 1982 - Texaco, Incorporated). [Additional Reference(s): DWR Levee Log, 2002]. FS Date: 6/16/2016 10:00:15 AM

Landside view: overview gasoline indicator

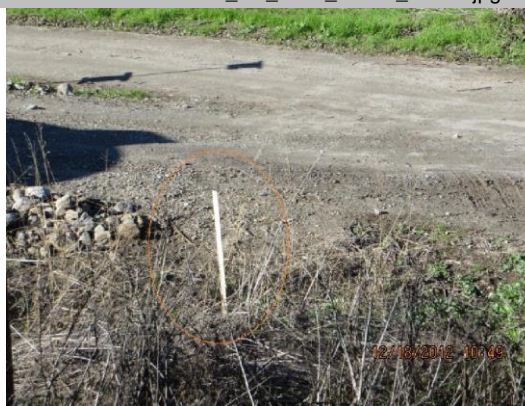
Photo 3 of 3 : UCIP_SP_2019_49161_47478.jpg

Comment Code						
Inspector Comment						
FS_ID:49161 DS_ID:17531 EP_NO: 13534 Repair Type: Non-Urgent Crossing Status: Indicator Found UCIP Comments: 6/3/2016 Crossing appears to be in good condition.4/6/2015 Same as last inspection. May need to add more substantial gasoline markers.7/7/2014 Same as last inspection.12/19/2013 Same as last inspection.7/22/2013 Same as last inspection. FIELD_STRUCT_DESC: 2.5-inch asphalt coated steel gas pipeline through the levee, 2.5 feet below the crown. A gas line marker found on the landside (LS). (Permit No. 13534, 1982 - Texaco, Incorporated). [Additional Reference(s): DWR Levee Log, 2002]. FS Date: 6/16/2016 10:00:15 AM

Landside view: gasline indicator

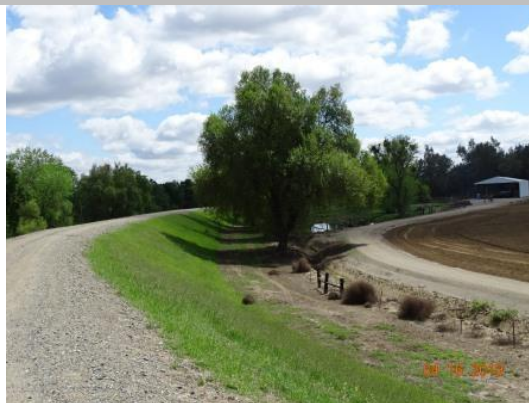
Photo 1 of 1 : SP_2019_ST0003_267_1_20190418_00001.jpg

LM Start	0.00	Rating **	A	Issue No.	1
LM End	0.30	Issue Type +	Ma	Location *	LS
Category	Earthen Levee			GPS Latitude/Longitude	
				Start	End
Item	Vegetation			39.338139 °	39.336011 °
				-122.022164 °	-122.017552 °
DWR ID	DWR_ST0003_04_s_2019_1				
Comment Code					
V1 : Control annual grass and weeds on the levee slopes and easements.					
Inspector Comment					
The annual vegetation on both the landside and waterside is well maintained.

View of the vegetation on the landside slope. Spring 2019.

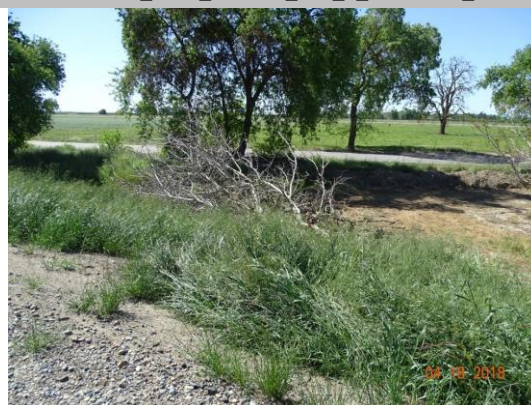
Photo 1 of 1 : SP_2019_ST0003_268_5_20190327_00002.jpg

LM Start	0.71	Rating **	M	Issue No.	5
LM End	0.71	Issue Type +	En	Location *	WS
Category	Earthen Levee			GPS Latitude/Longitude	
				Start	End
Item	Encroachments			39.341167 °	39.341167 °
				-122.010412 °	-122.010412 °
DWR ID	DWR_ST0003_05_s_2018_5				
Comment Code					
PR : Prunings					
Inspector Comment					
Remove the prunings from the waterside toe.

View of the prunings along the waterside toe.

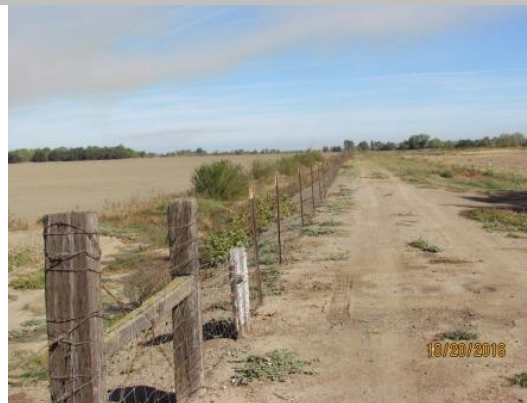
Photo 1 of 1 : SP_2019_ST0003_268_1_20190327_00001.jpg

LM Start	1.59	Rating **	M	Issue No.	1
LM End	2.18	Issue Type +	En	Location *	CR
Category	Earthen Levee			GPS Latitude/Longitude	
				Start	End
Item	Encroachments			39.335953 °	39.336852 °
				-121.995807 °	-121.984934 °
DWR ID	DWR_ST0003_05_s_2016_1				
Comment Code					
FE : Fence					
Inspector Comment

View of the fence obstructing access.
